NASA CR-129041

CHARACTERIZATION OF METALS MELTING DISCS
SKYLAB EXPERIMENT M551

By Robert E. Monroe
Battelle Columbus Laboratories
Columbus, Ohio 43201

January 1974

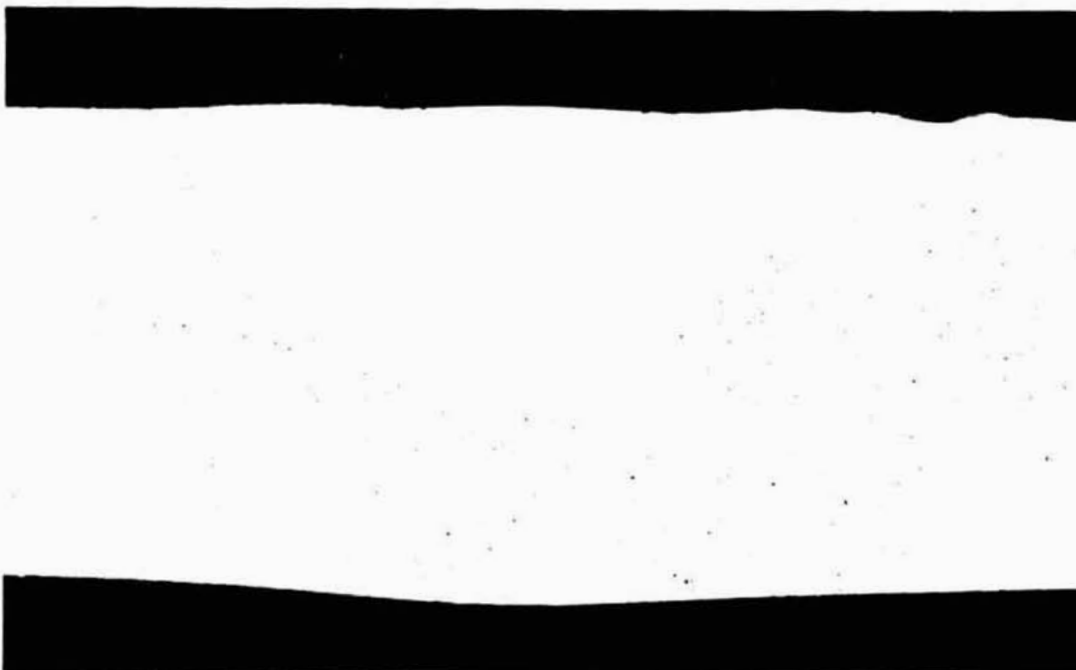
No defects were noted in the radiograph except for cracks at the weld stops and dwells. Figure A-2 shows the appearance of this disc as received. The black area is a molybdenum spray coating used for a tracer. A section through the weld zone in the area of the tracer is shown in Figure A-3. No adverse effects of the tracer on the weld region were noted in this section.

Etched
FIGURE A-3. SECTION P-1 AT TRACER REGION 5G265-20X

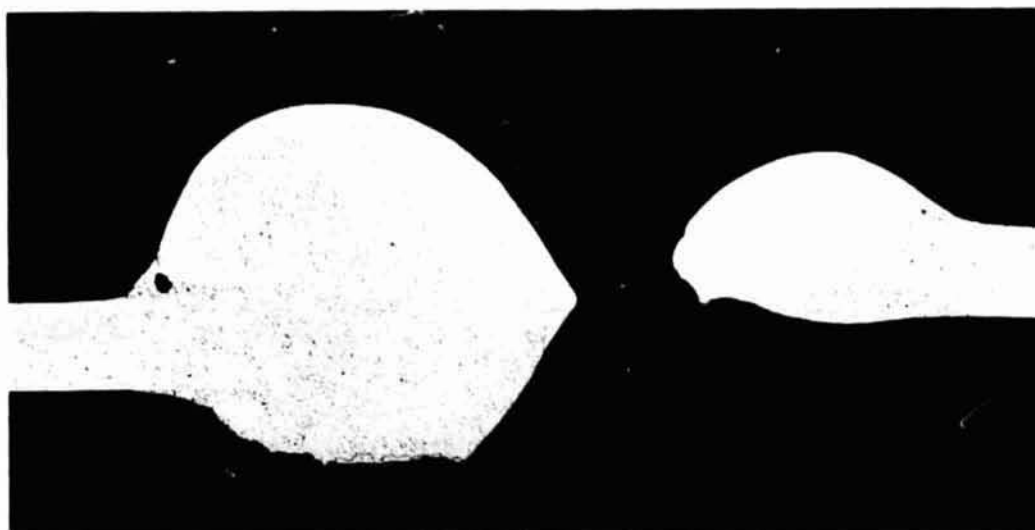
Figures A-5 through A-10 show the appearance and microstructural details in the cut region. Several areas on the cut surfaces indicate the presence of a contaminant or reaction zone. This has probably come from material vaporized from the surface under the weld disc. The very wide cut that resulted in this disc is

FIGURE A-5. SECTION THROUGH CUT REGION -H-1

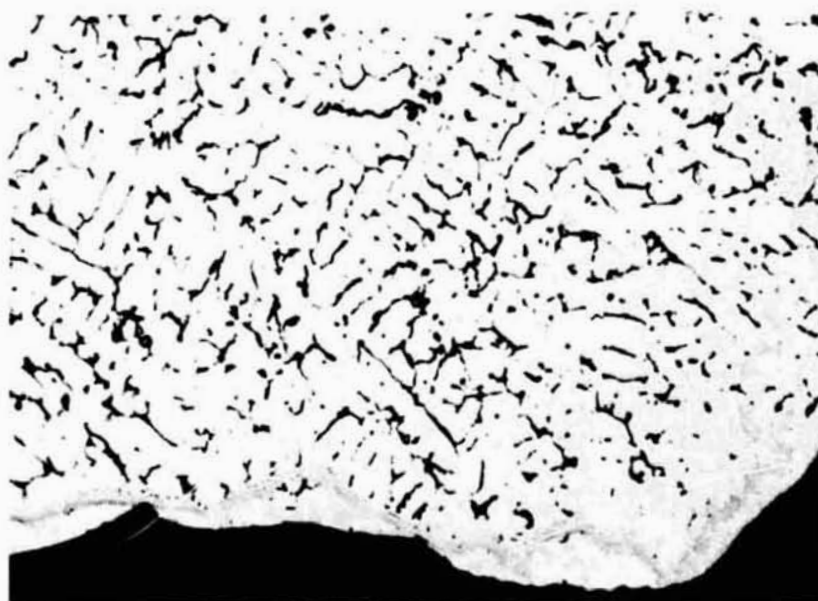
a. Enlarged area of Figure A-6

b. Bottom surface of cut on outside

FIGURE A-7. SURFACE OF CUT -H-1

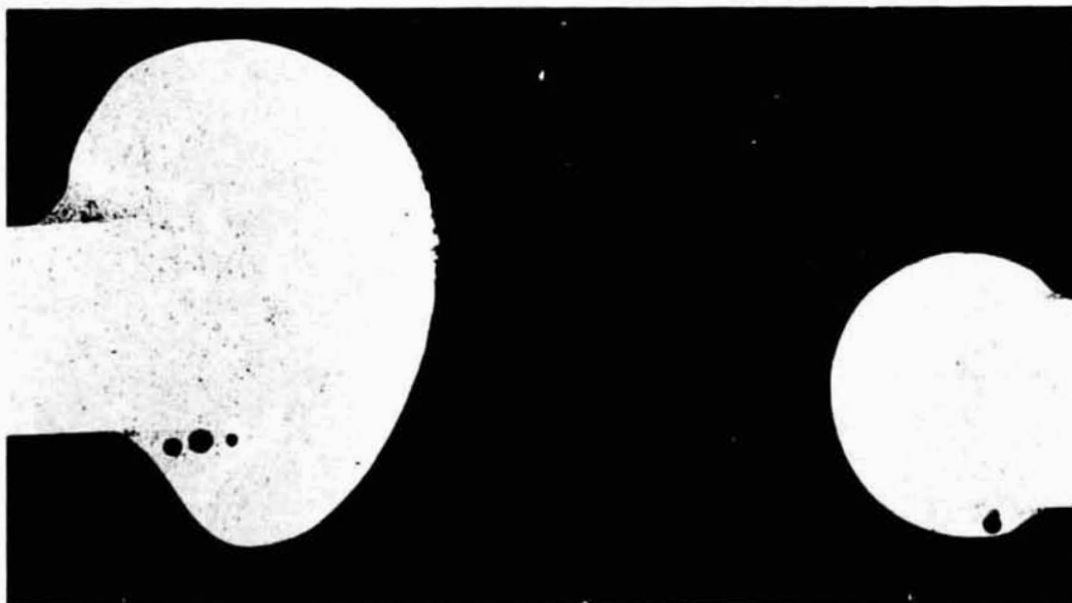
FIGURE A-9. SECTION THROUGH RAMP REGION -H-1

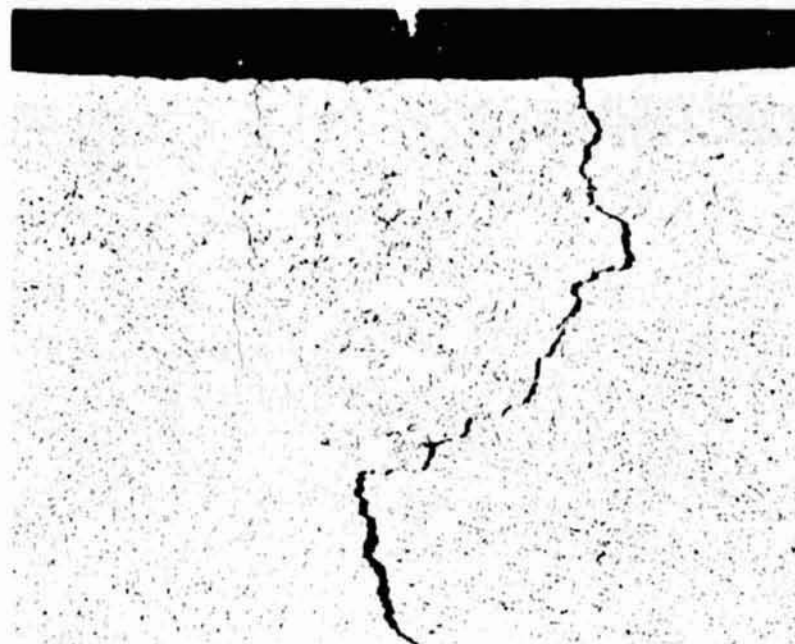
FIGURE A-12. ENLARGEMENT OF LONGITUDINAL CRACK
AT WELD START - H-1

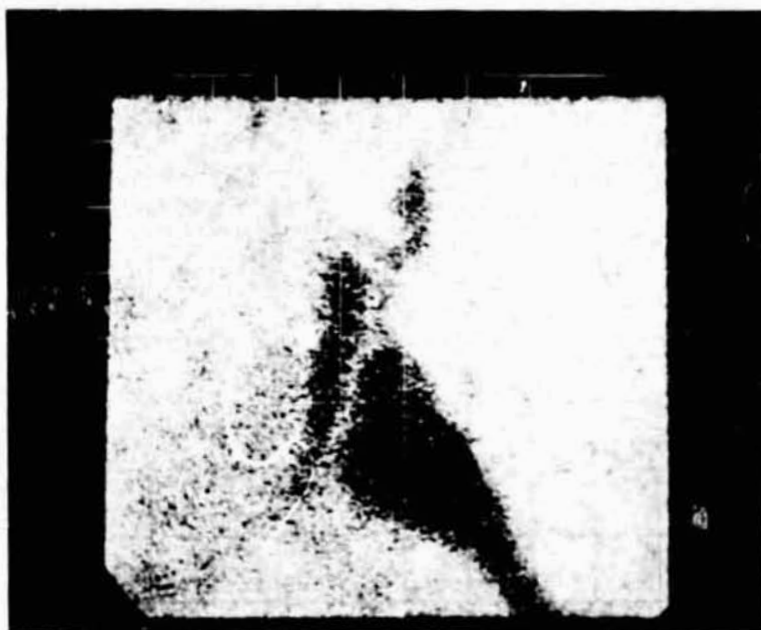
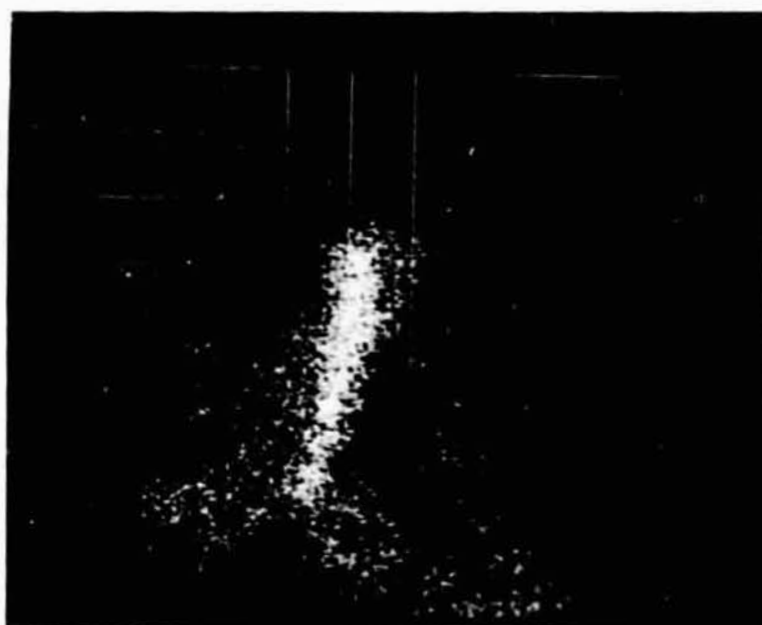
FIGURE A-24. ELECTRON PROBE SCANS OF REGION
SHOWN IN FIGURE A-21 - LARGE
PARTICLE AT LEFT CENTER ADJACENT
TO END OF CREVICE - H-1

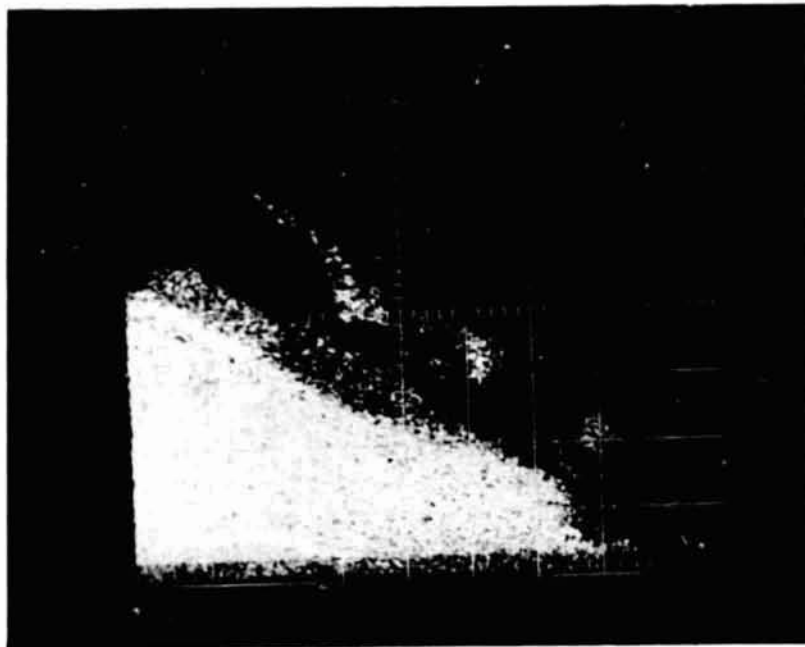
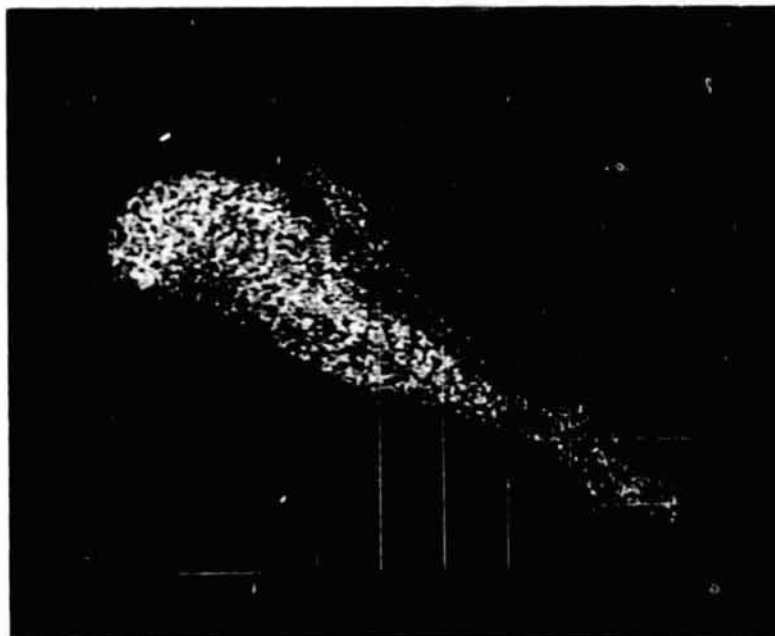
FIGURE A-25. ELECTRON PROBE SCANS OF REGION
SHOWN IN FIGURE A-16 - LARGE
PARTICLE AT TOP RIGHT SURFACE -H-1

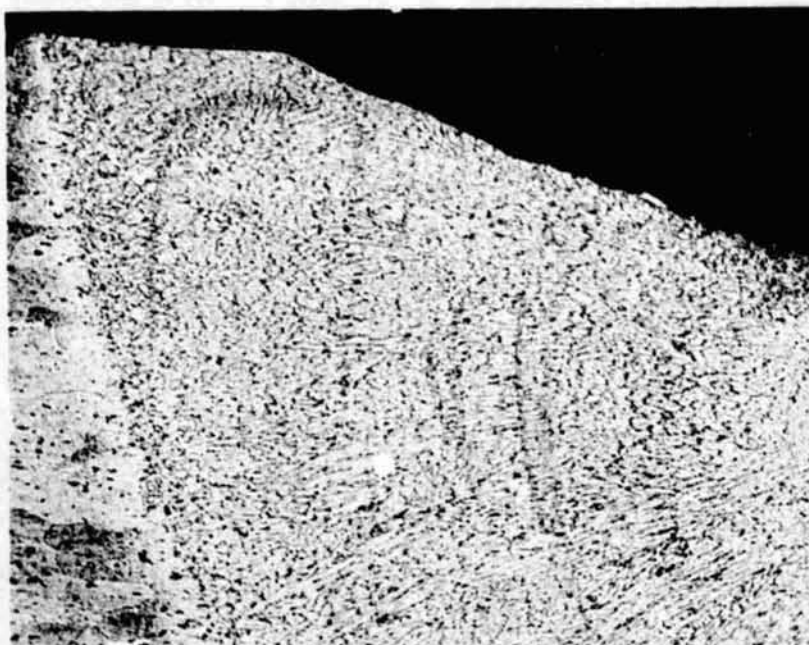
a. Left fusion line

b. Weld surface

FIGURE A-28. ENLARGED AREAS OF PARTIAL
PENETRATION REGION S/N 124

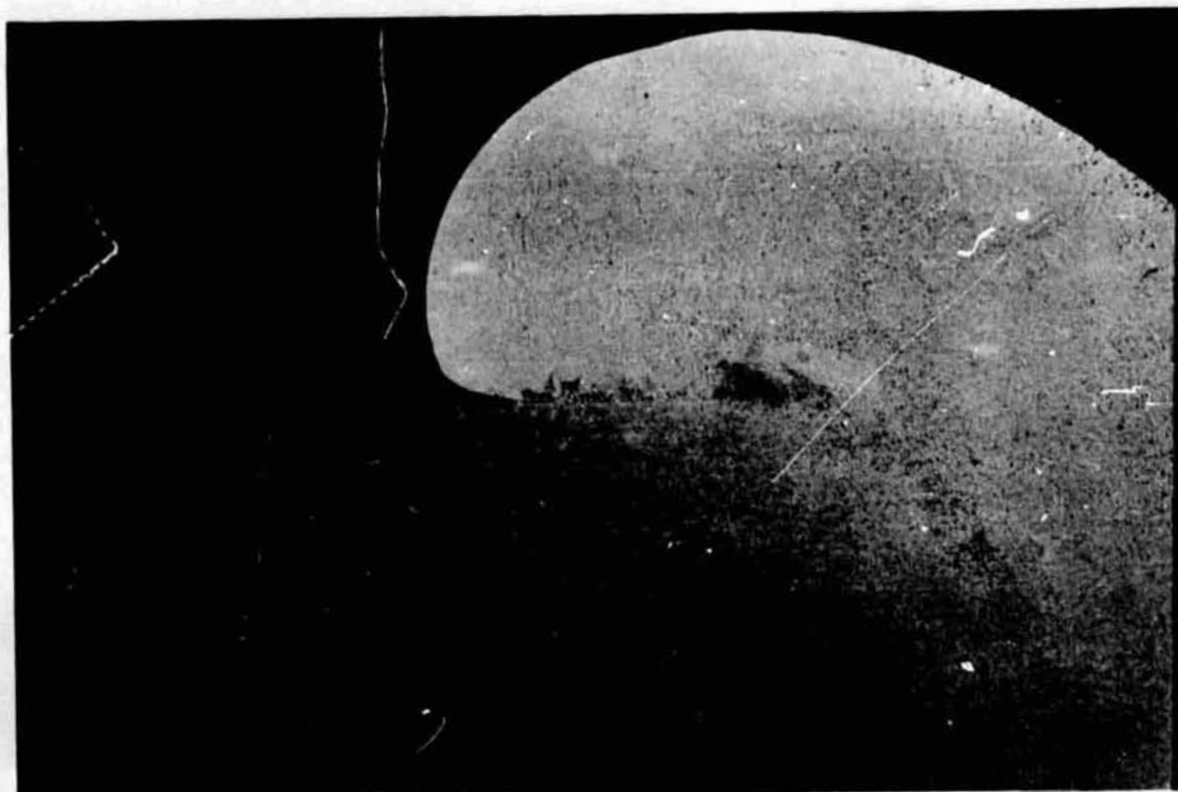
28 FIGURE A-31. CHORD SECTION THROUGH DWELL REGION
S/N-124

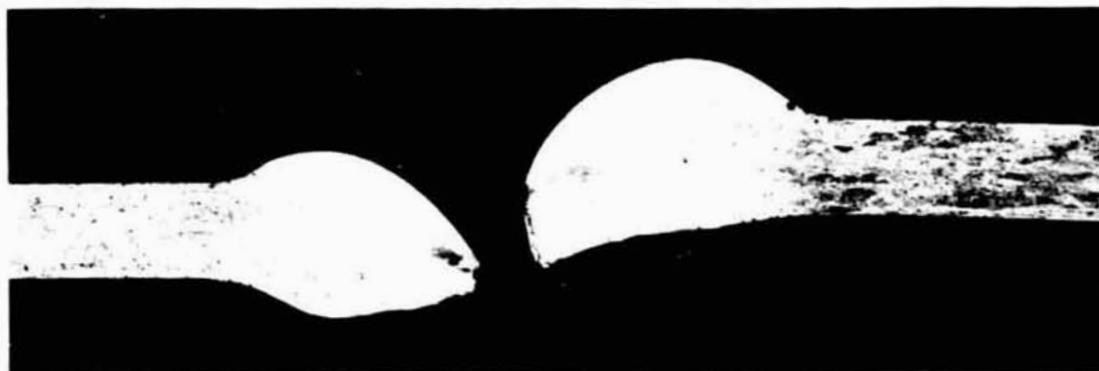
Etched
a. Cut Region

Etched
b. Outside Region

Etched
c. Inside Bead

FIGURE A-35. SECTION THROUGH CUT
REGION - S/N 132

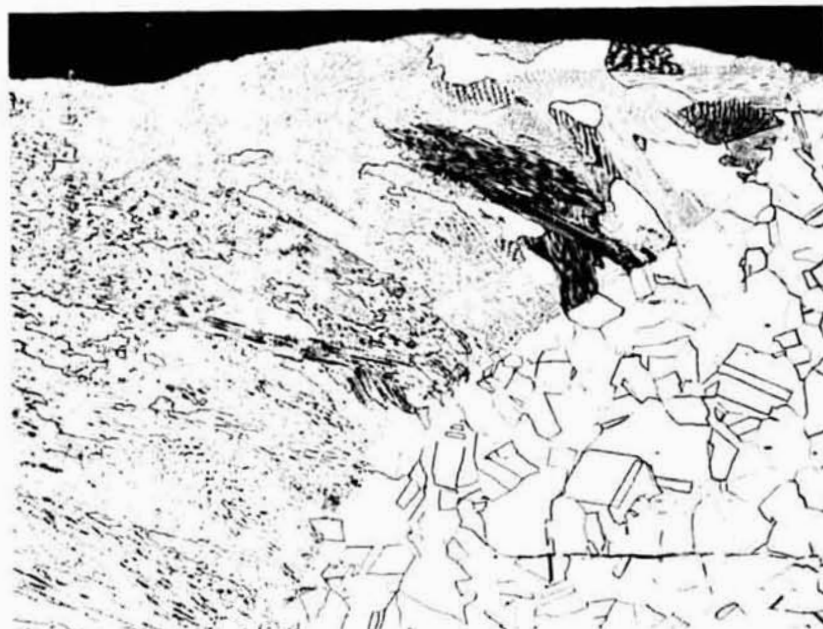
FIGURE A-43. FUSION LINE REGION
S/N 104

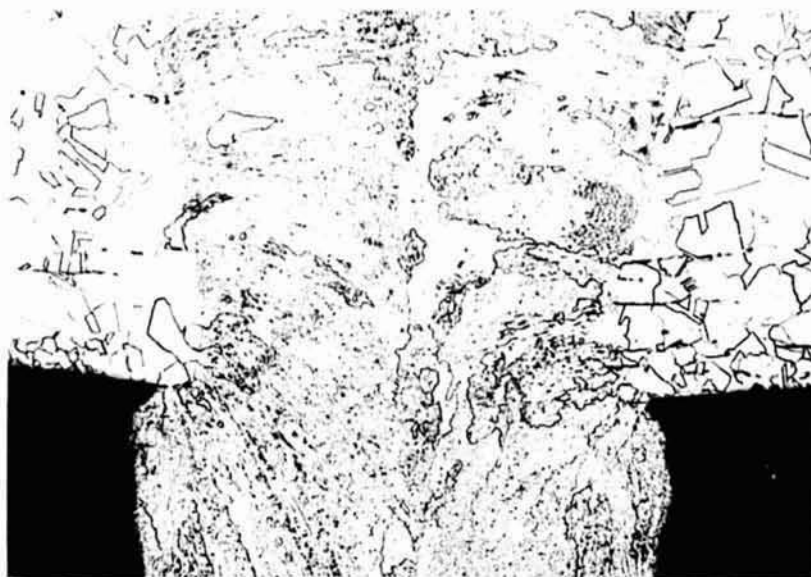
FIGURE A-45. SECTION AT ROOT OF WELD

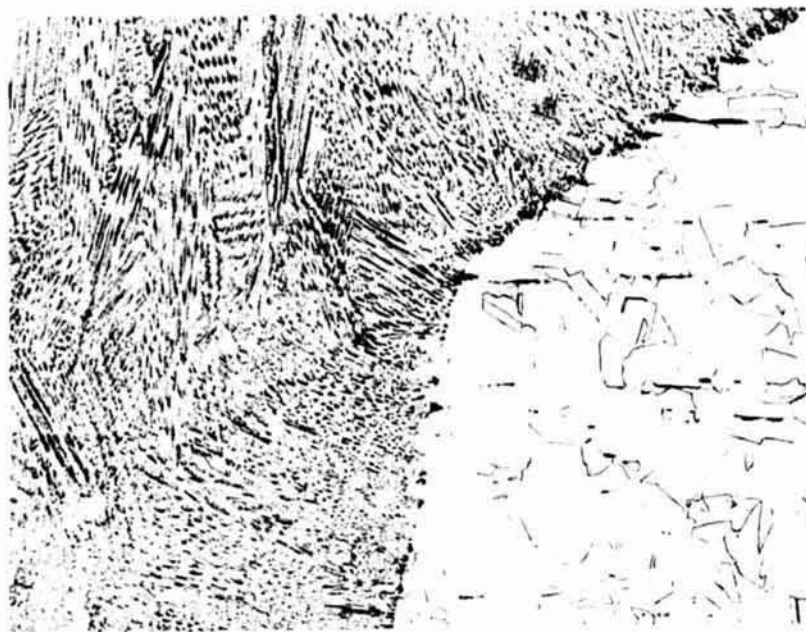
FIGURE A-47. FUSION LINE REGION
AT SHAPE CHANGE

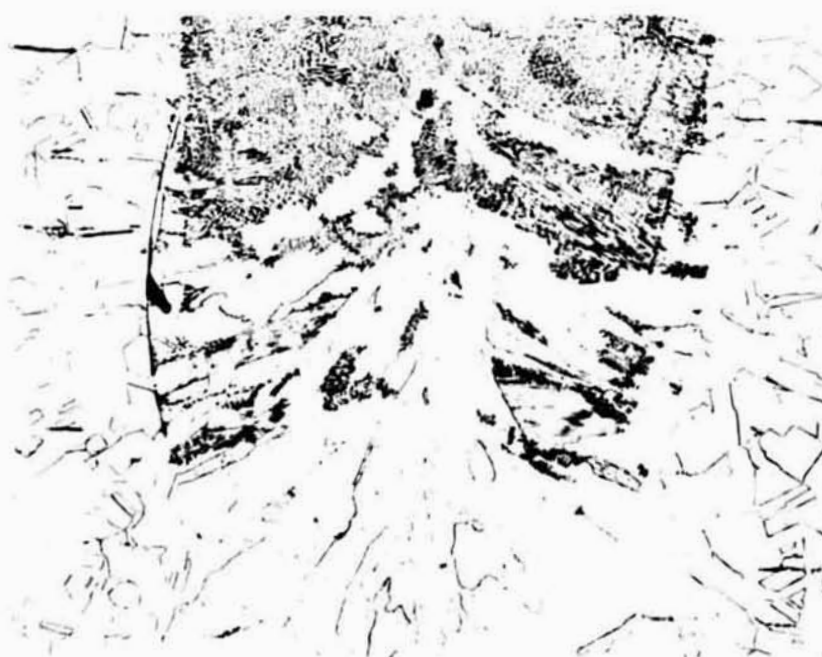
a. Fusion Line at Top

b. Root of Weld

FIGURE A-49. WELD STRUCTURES - S/N 104

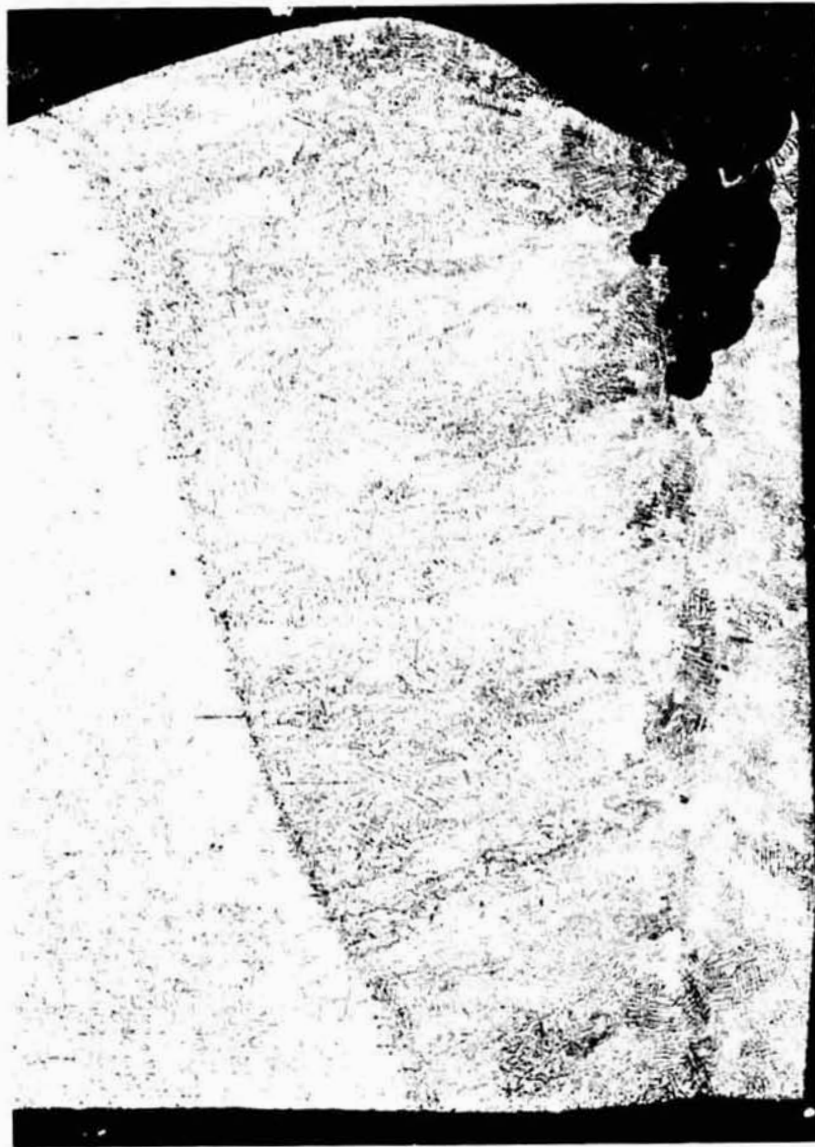
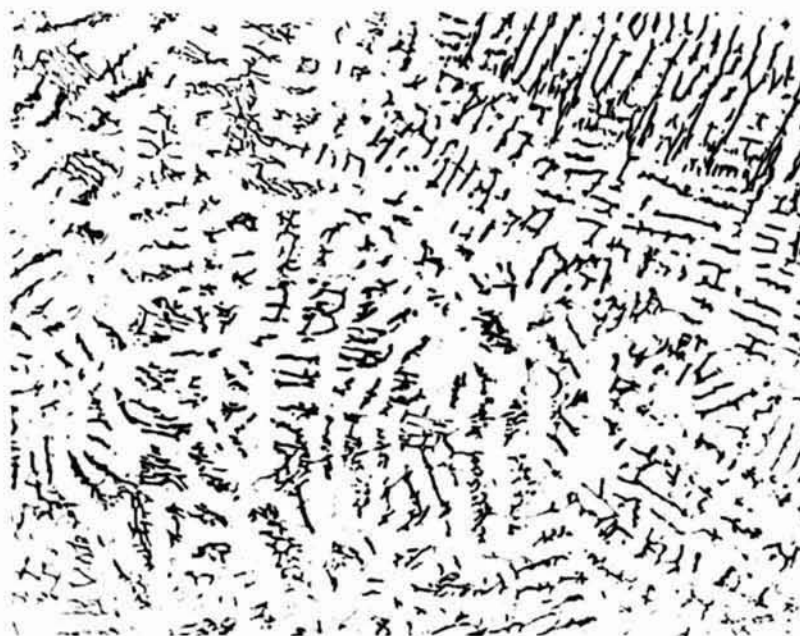
a. Chord Section

FIGURE A-50. SECTIONS THROUGH DWELL REGION - S/N 104

b. Top Edge Fusion Line

c. Typical Weld Microstructure

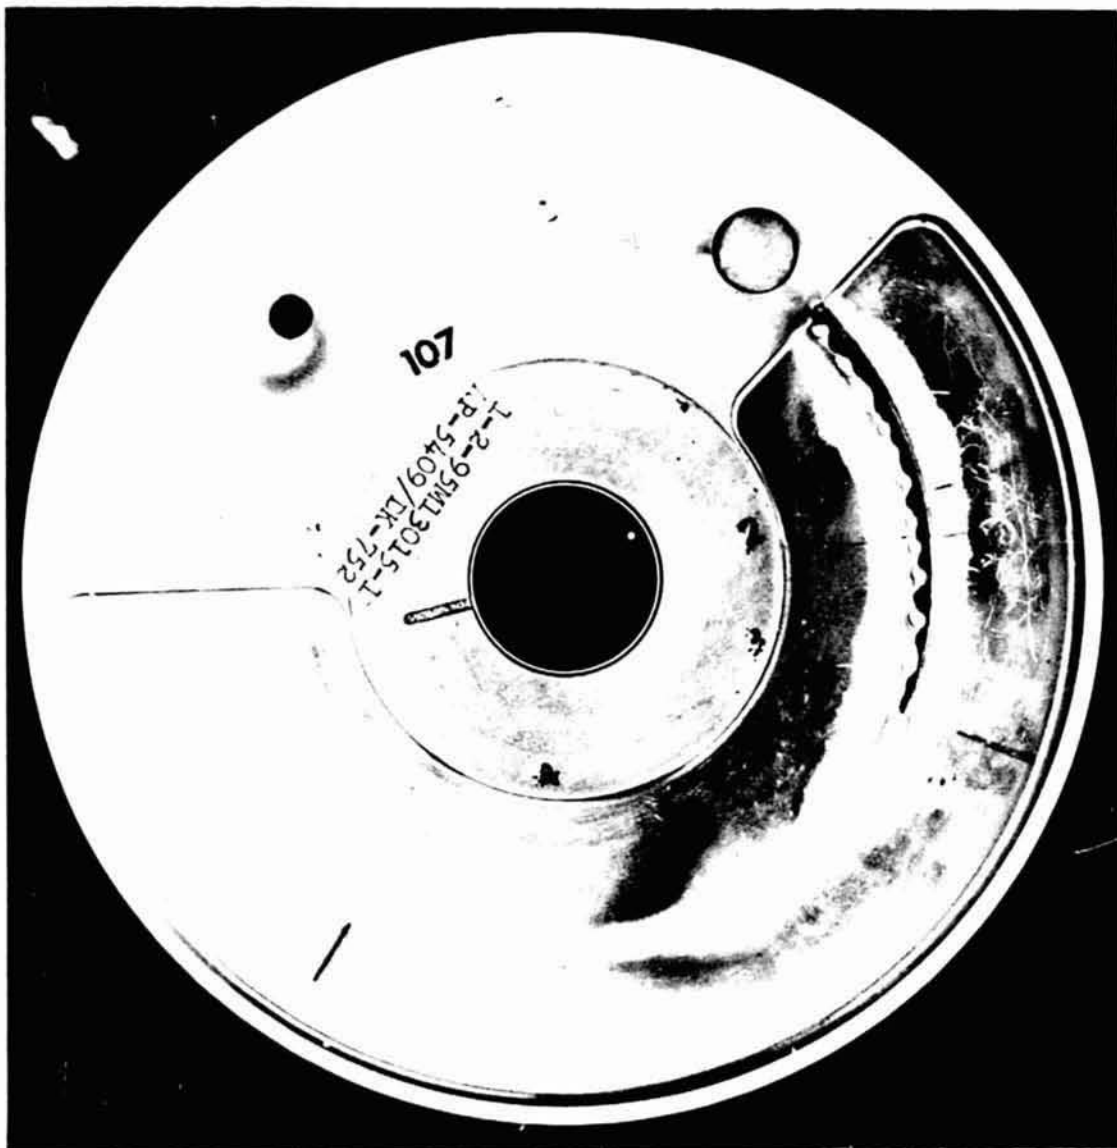
FIGURE A-52. BACK SURFACE - S/N 107

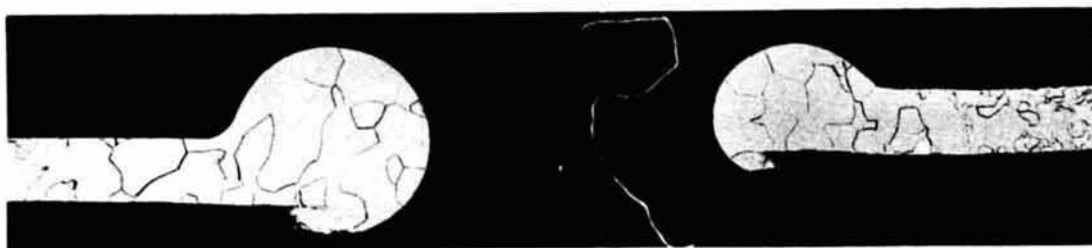
FIGURE A-57. SECTION THROUGH CUT REGION
S/N 143

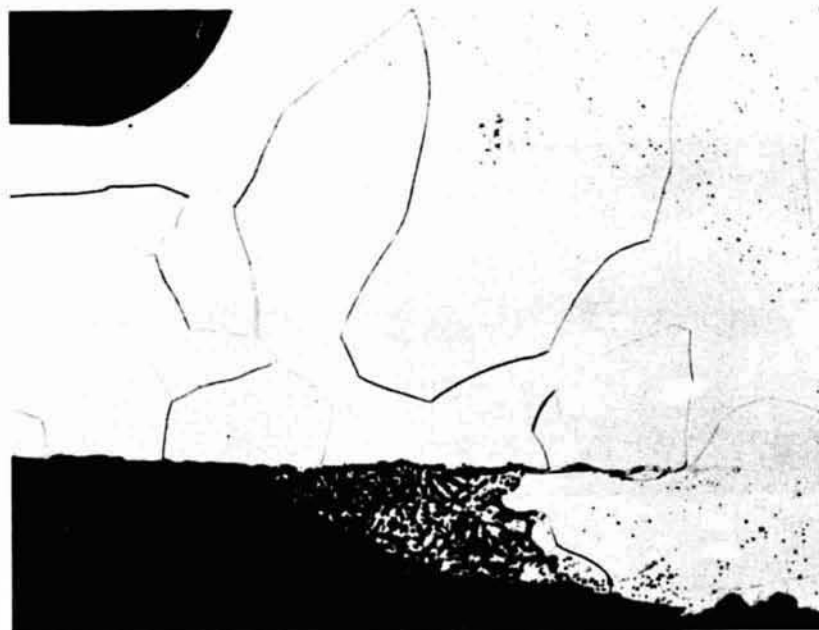
FIGURE A-58. BOTTOM SURFACE OF OUTSIDE
CUT EDGE S/N 143

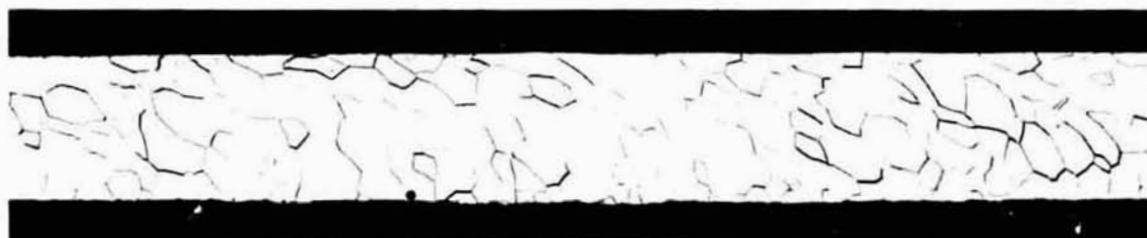
FIGURE A-67. CHORD SECTION THROUGH FULL
PENETRATION REGION S/N 158

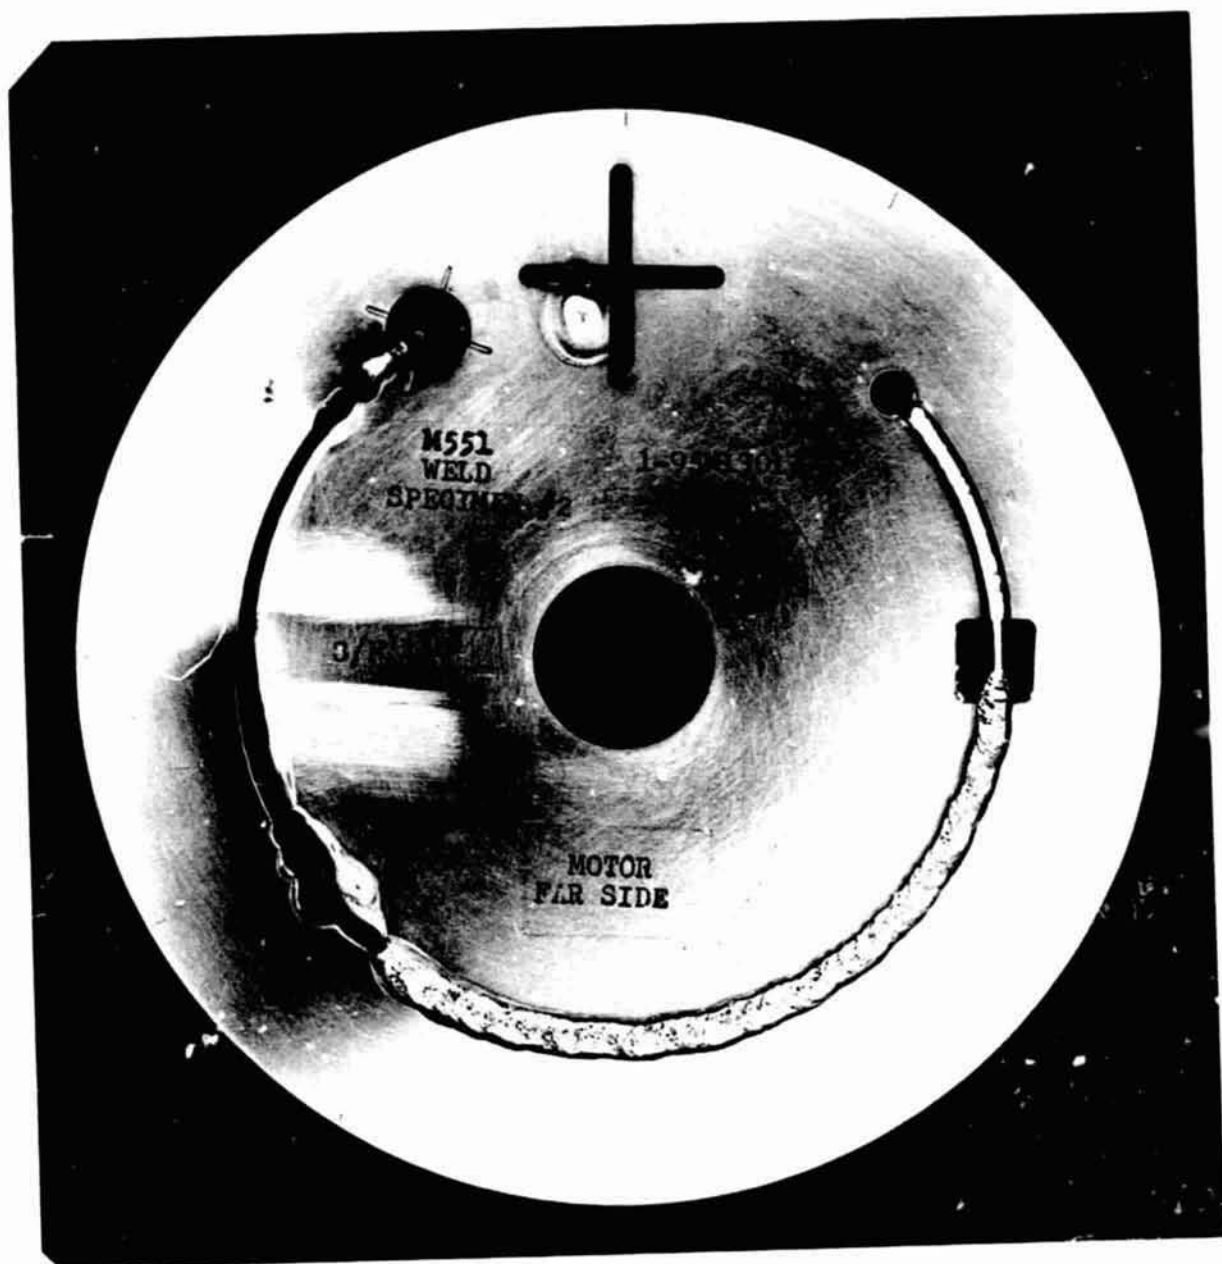
FIGURE B-1. FRONT SURFACE S/N 130

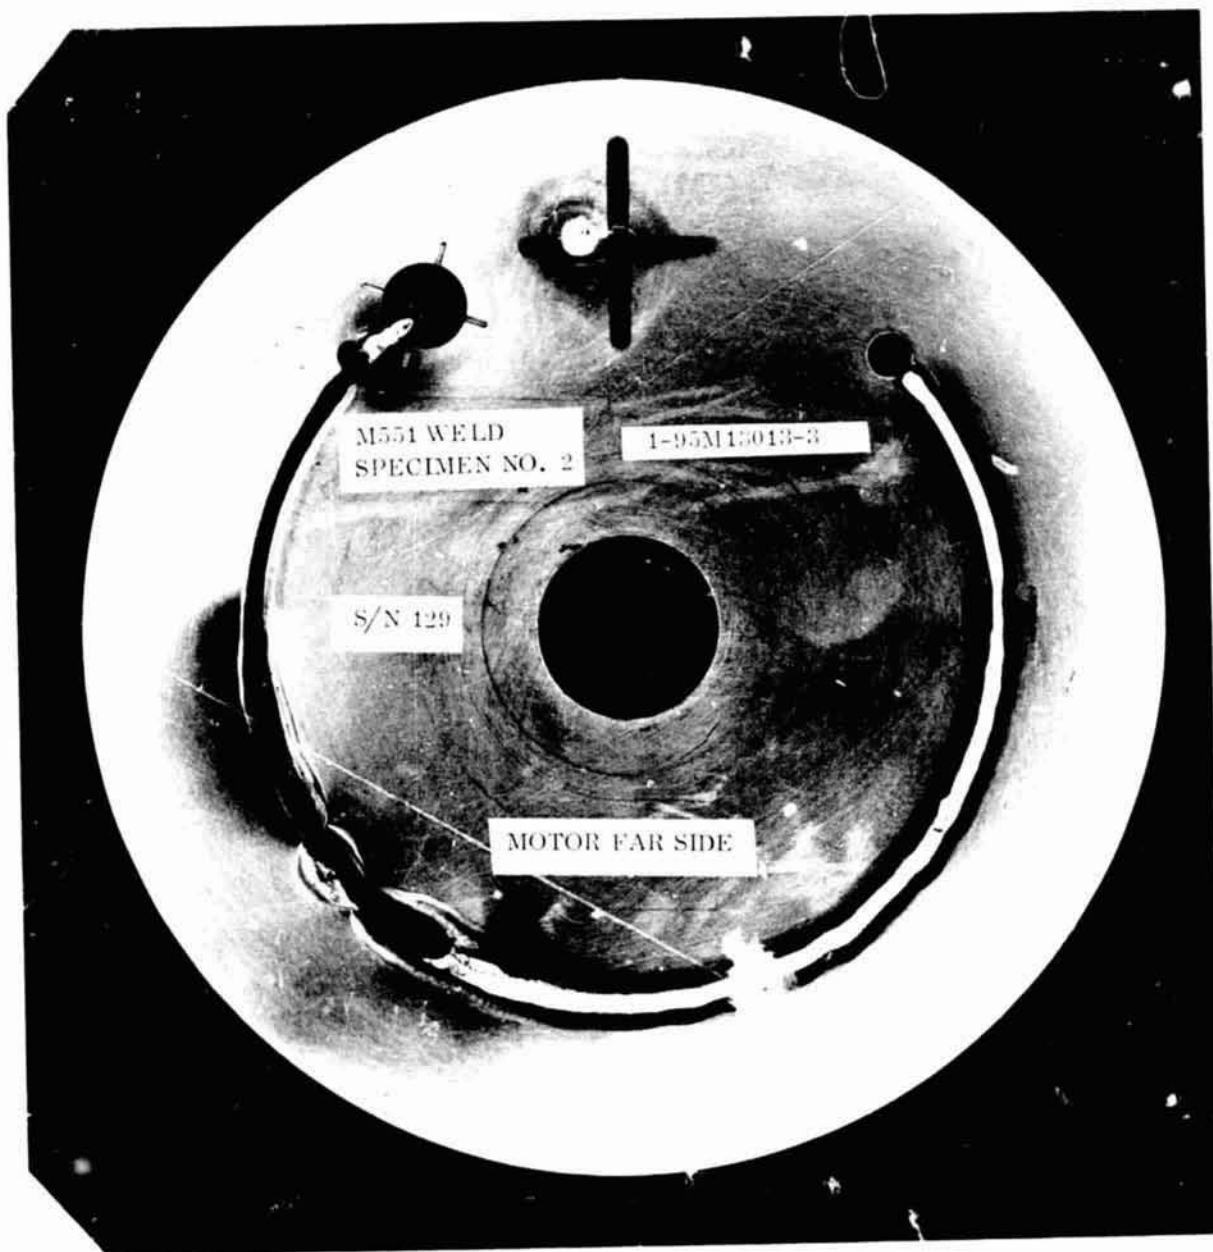
FIGURE B-3. FRONT SURFACE S/N 129
